HOUSATONIC RIVER BASIN 1997/1998 WATER QUALITY ASSESSMENT REPORT

COMMONWEALTH OF MASSACHUSETTS
EXECUTIVE OFFICE OF ENVIRONMENTAL AFFAIRS
BOB DURAND, SECRETARY
MASSACHUSETTS DEPARTMENT OF ENVIRONMENTAL PROTECTION
LAUREN A. LISS, COMMISSIONER
BUREAU OF RESOURCE PROTECTION
ARLEEN O'DONNELL, ASSISTANT COMMISSIONER
DIVISION OF WATERSHED MANAGEMENT
GLENN HAAS, DIRECTOR

HOUSATONIC RIVER BASIN
1997/1998 WATER QUALITY ASSESSMENT REPORT

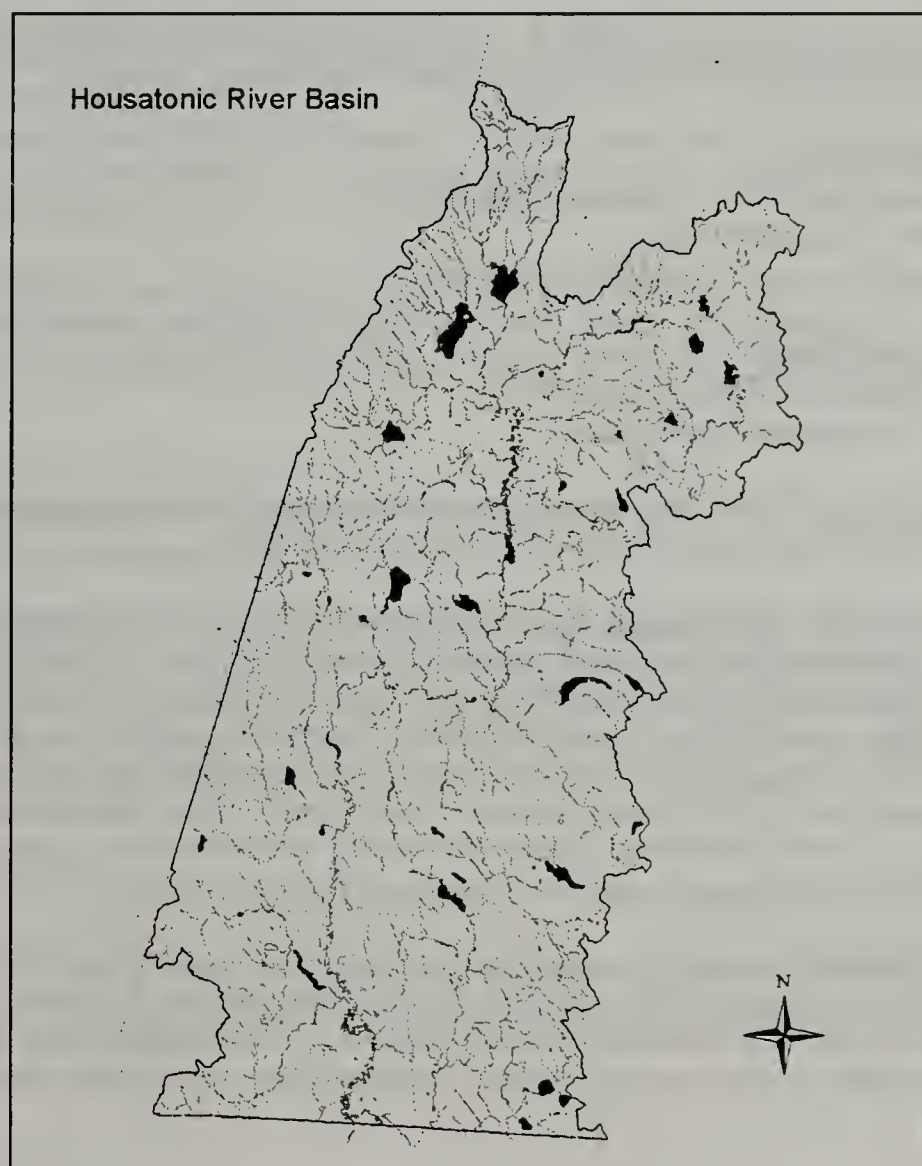
Figure 5. Location of Massachusetts lakes assessed in the Housatonic River Basin.

A total of 32 lakes, ponds or impoundments (the term "lakes" will hereafter be used to include all) have been assessed in the Housatonic River Watershed. Eleven of the lakes 32 lakes assessed are less than 50 acres in total surface area. The lakes surveyed in 1997 are located wholly or partly within 19 different communities and are fairly evenly distributed among them. Of the 5,227 acres of lakes in the Housatonic River Basin, 81%, or 4,254 acres, was assessed during the 1997 surveys. Designated water supplies (i.e., Class A) accounted for 12% (or 530 acres) of the assessed acreage.

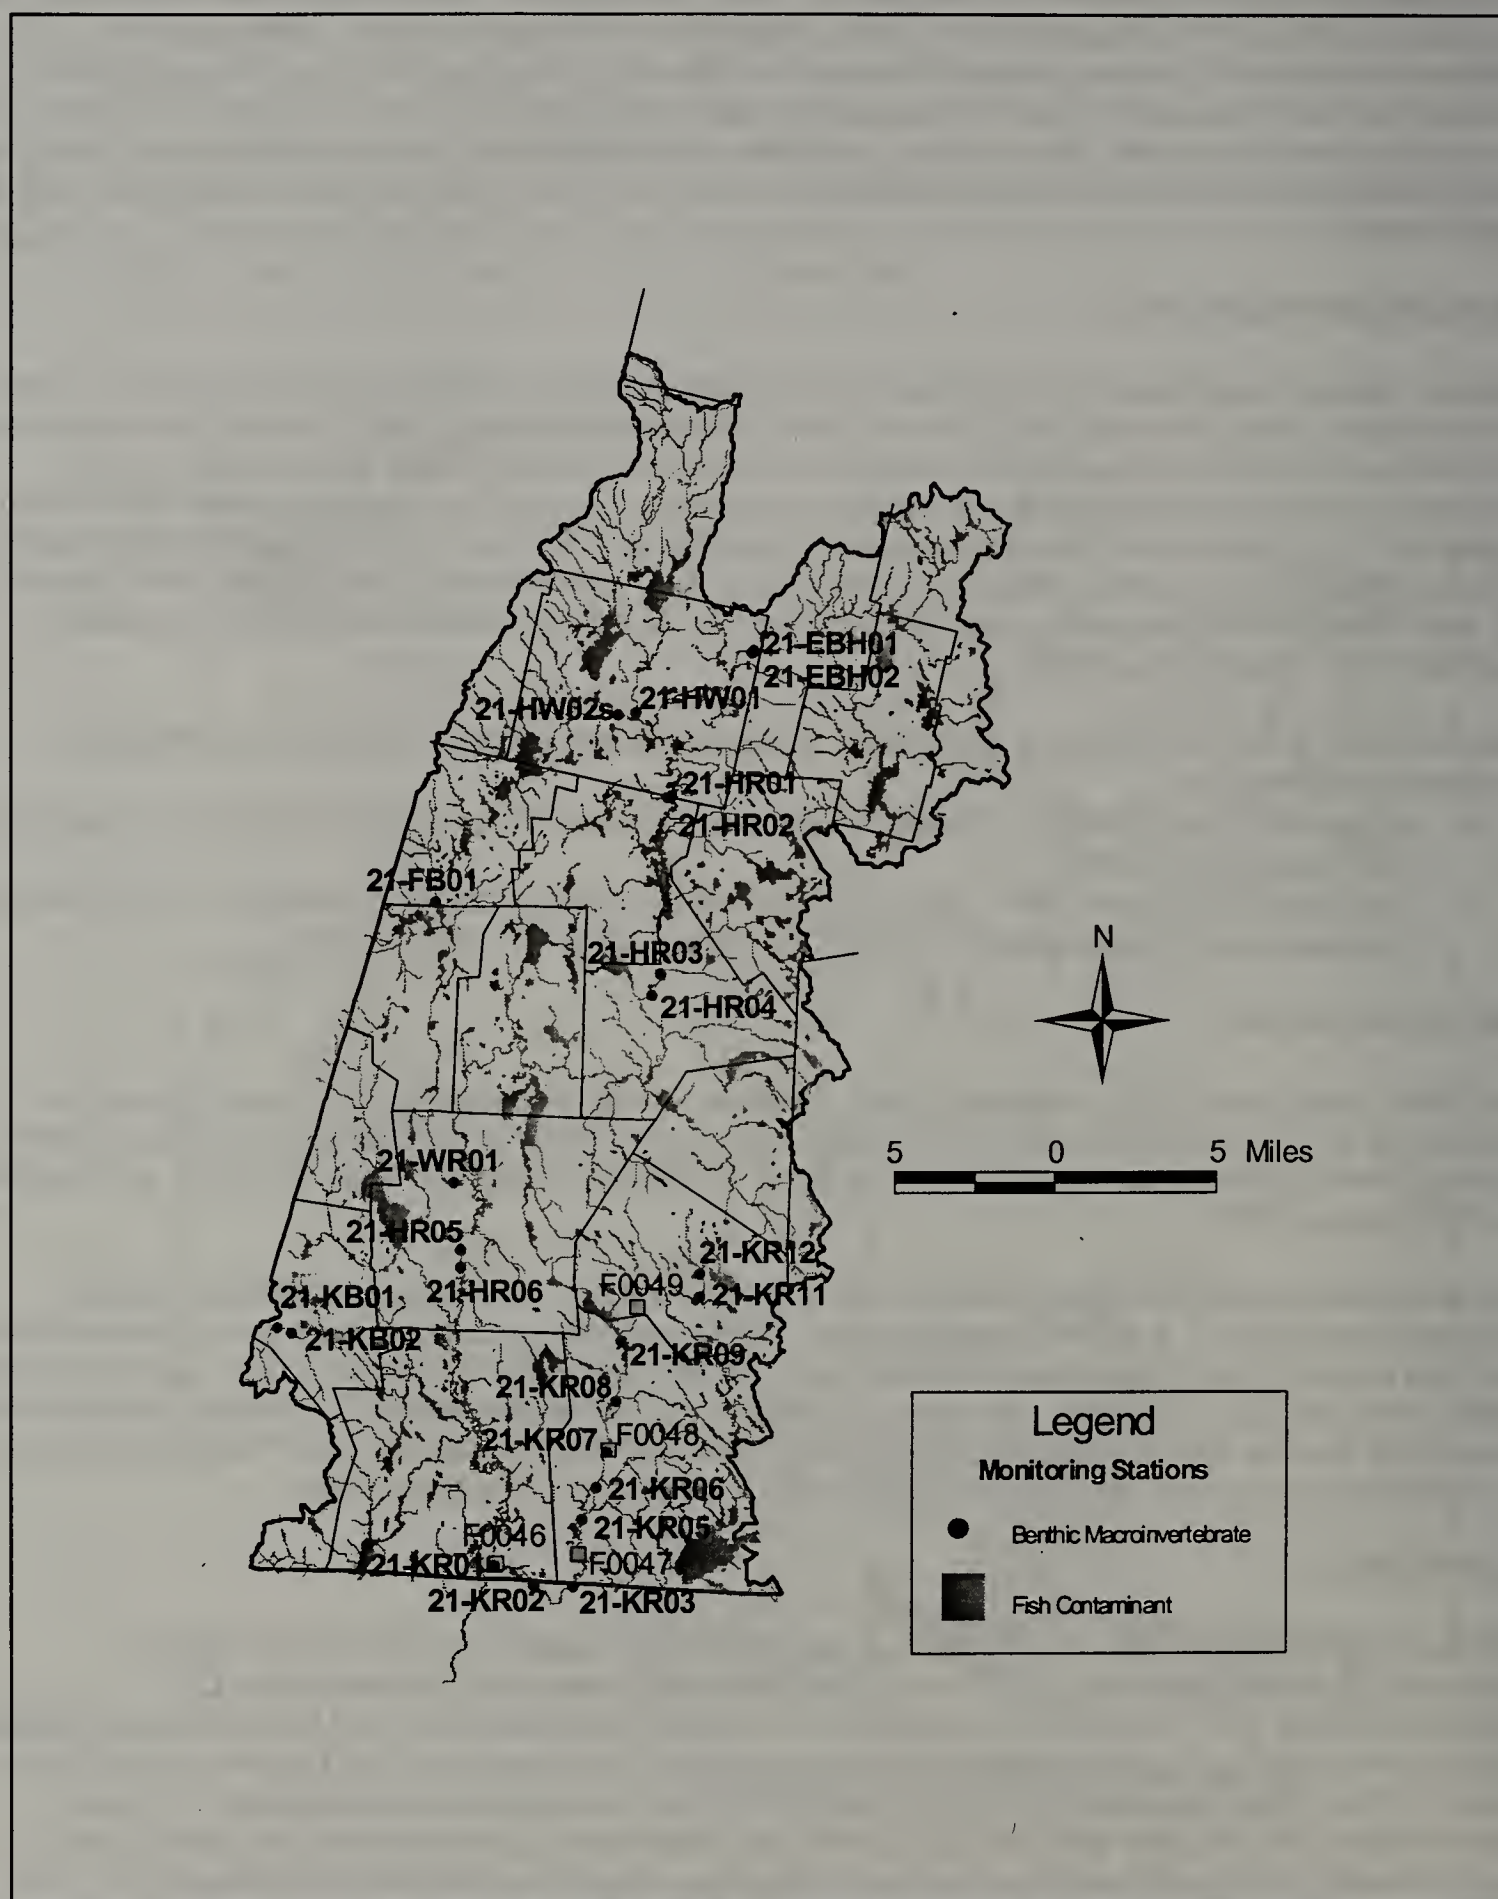
Figure B3. Location of 1997 DWM benthic macroinvertebrate sampling and fish contaminant monitoring stations sampled in the Housatonic River Watershed.
